Volume II-Problem Area Analysis

Luzerne County Act 167 Phase II

Stormwater Management Plan

June 30, 2010

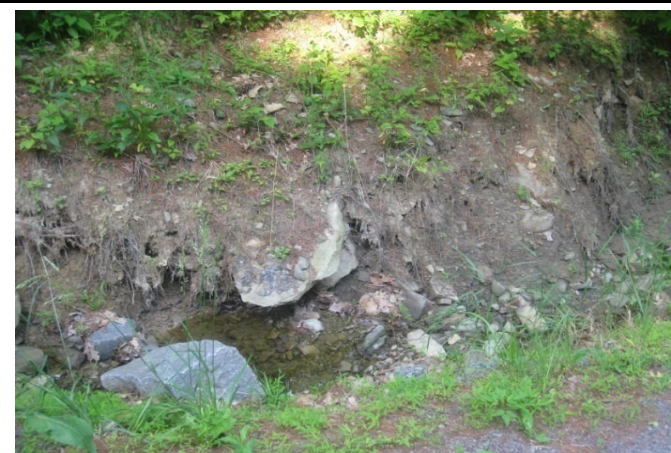
Description
	Bank erosion along the roadside swale. During a field visit, up to 4 feet of erosion was observed in some locations.

Solution	5.6.3, 6.4.4, 6.4.8, 6.B, 6.C
----------	-------------------------------

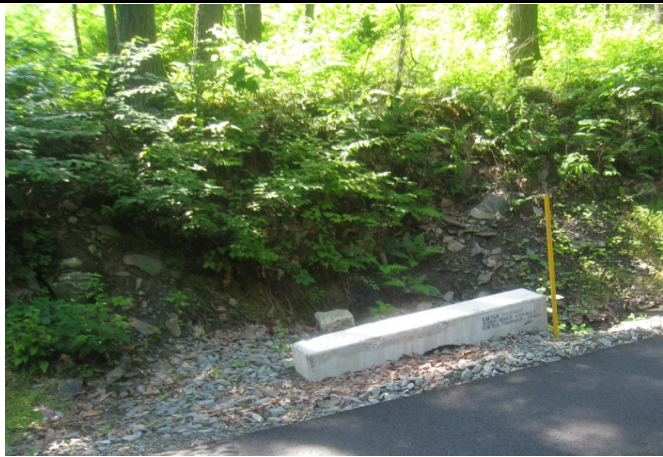
<div style="padding-left: 10px;"> <p>New 18" CMP culvert and rock lined swale along Lewis Road.</p> </div> </div>

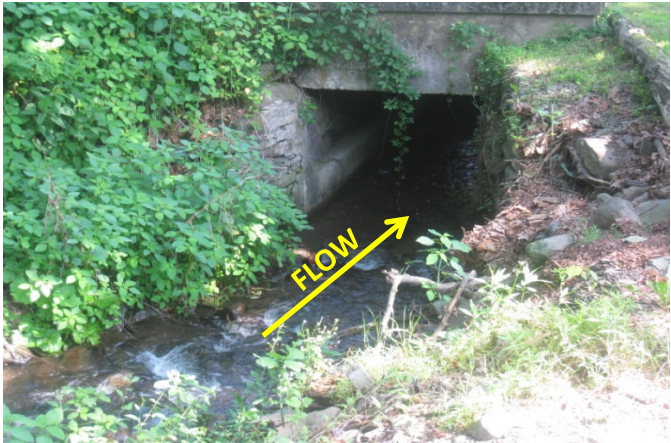
Upstream face of the culvert.

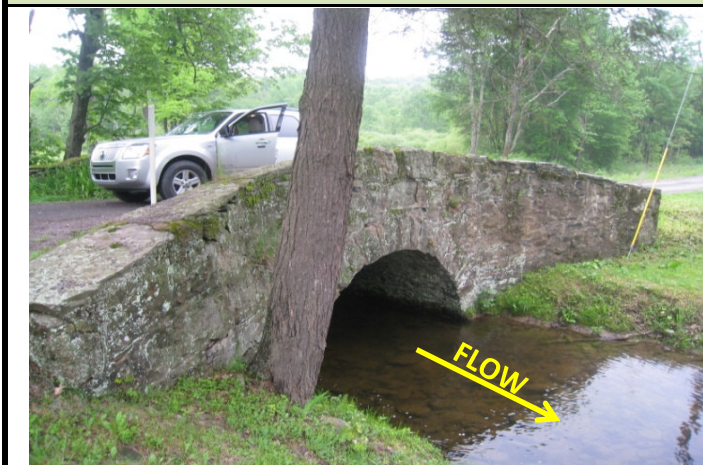
Description
Downstream face of the stone arch bridge.

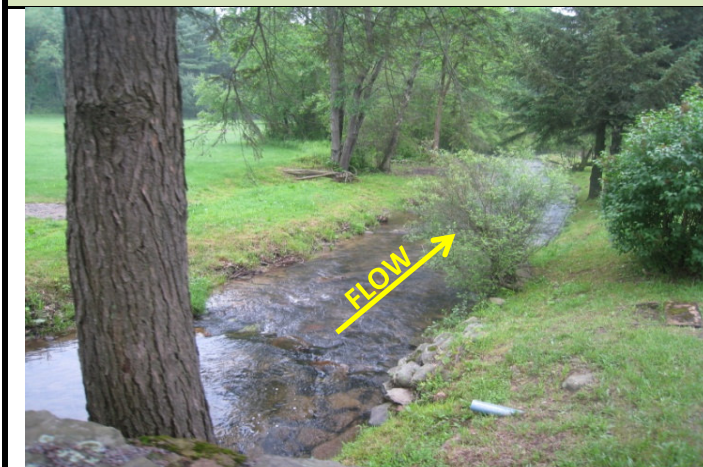
Description
Looking downstream from the bridge. Shallow channel may overtop during heavier rains.

Solution	5.4.1, 5.4.2, 6.7.1, 5.6.3, 6.A, 6.B
----------	--------------------------------------

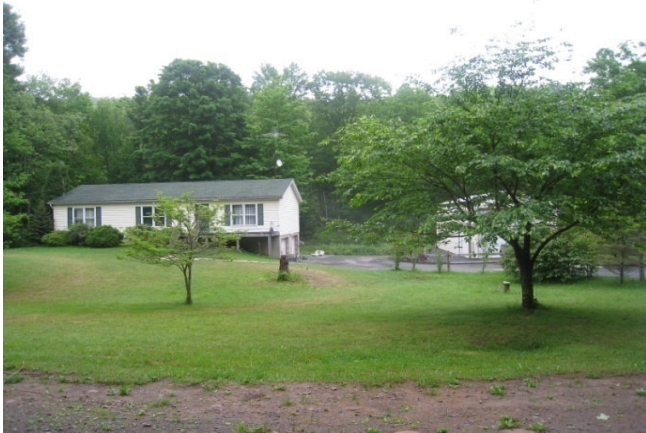
</div> <div style="width: 50%; padding-left: 10px;"> <p>Information provided by the forms indicate that erosion was present along the right streambank within one foot of the garage. Access to the property for closer observation could not be obtained.</p> </div> </div>

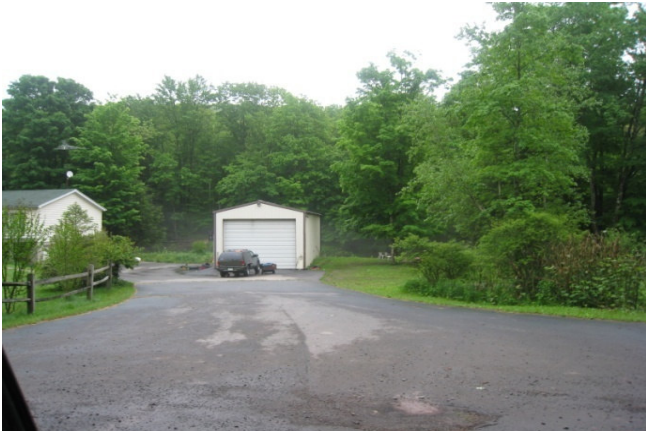
</div> <div style="width: 50%; padding-left: 10px;"> <p>Picture of the house along Huntington Road. The house is in close proximity to the Creek.</p> </div> </div>

Solution	5.4.2, 6.7.4, 6.A, 6.C
----------	------------------------

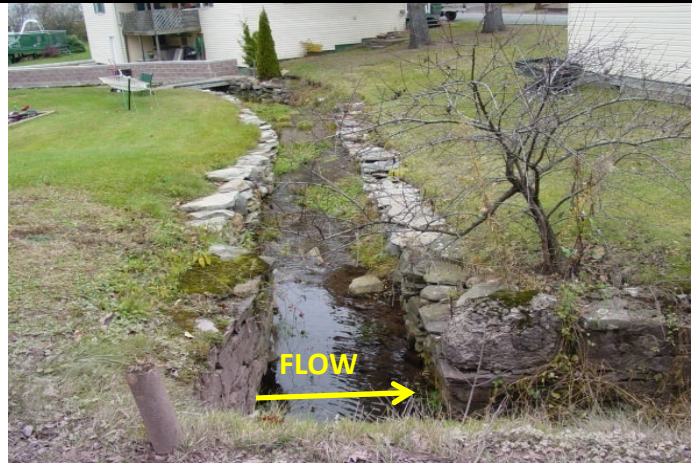
Upstream of the bend showing house in close proximity to channel.

Solution	5.4.2, 6.7.1, 6.A, 6.B
----------	------------------------

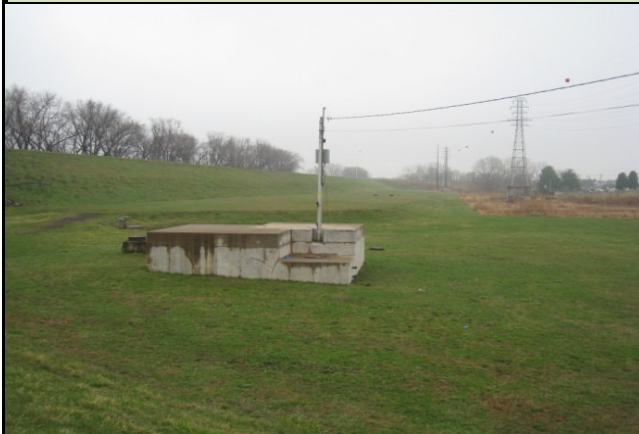
Looking down at a basin located near the Susquehanna River levee system. There is a building believed to be a pump station located next to the basin. The pump station conveys flows through the levee system during high water events on the Susquehanna River. Malfunctioning of the pump station would result in extended flooding.

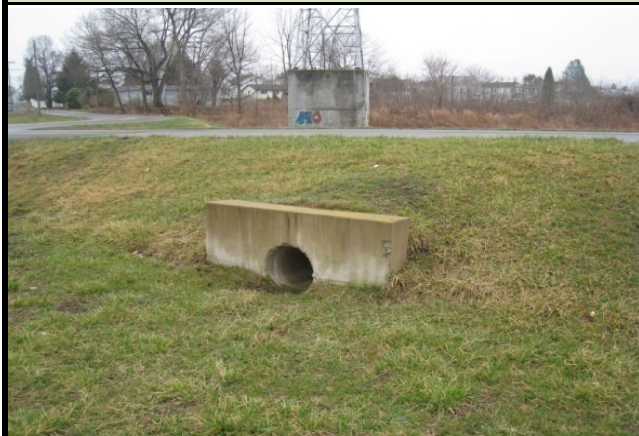
A culvert system connecting two basins. Multiple culverts connect several impounding areas. None appear to be clogged and all are in relatively good shape.

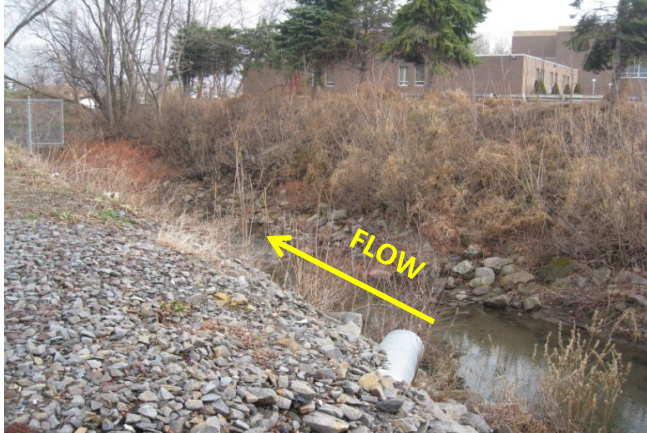
</div> <div style="width: 50%; padding-left: 10px;"> <p>Downstream of bridge looking downstream. The channel narrows and the streambanks are steep. The U-channel channel section begins behind the building shown on the right.</p> </div>

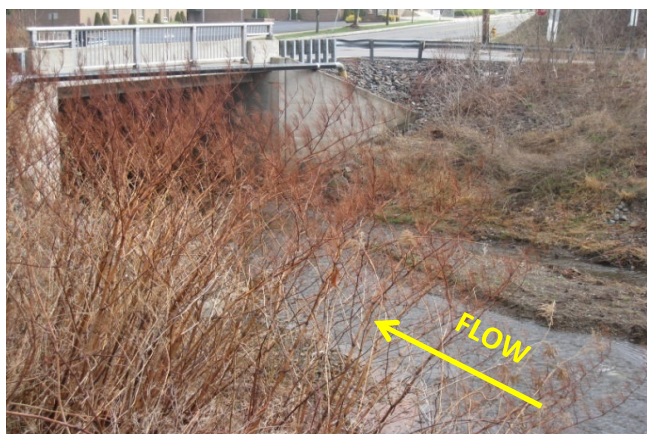
</div> <div style="width: 50%; padding-left: 10px;"> <p>View of upstream bridge face looking downstream.</p> </div>

Solution	5.4.2, 6.7.1, 6.A, 6.B
----------	------------------------

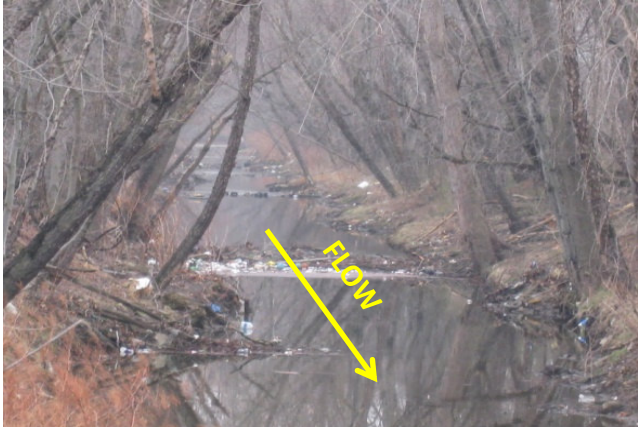
Description
	Looking upstream from Oxford St. Bridge over Solomon Creek. There is debris in segments upstream. The bridge at this location is undersized based on previous studies. The channel in this area is also essentially flat due to dredging and past filling of large size wetlands in this area.

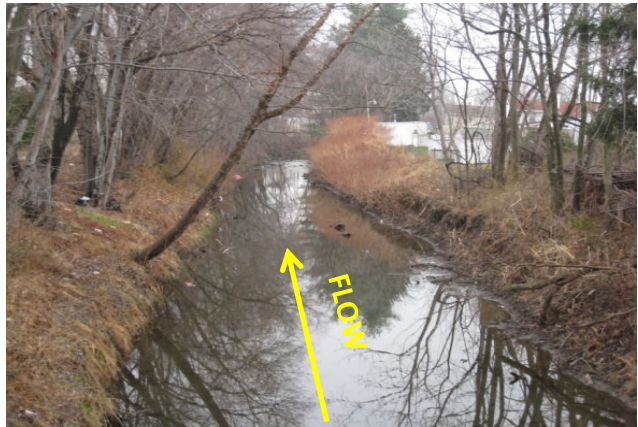
Description
	Looking downstream from Oxford St. bridge towards problem area HAN007. Banks are eroded, revealing root systems of trees and impairing tree stability. These trees could potentially be future obstructions to flow if bank erosion continues.

Solution	5.4.2, 6.7.1, 6.A, 6.B, 6.E
----------	-----------------------------

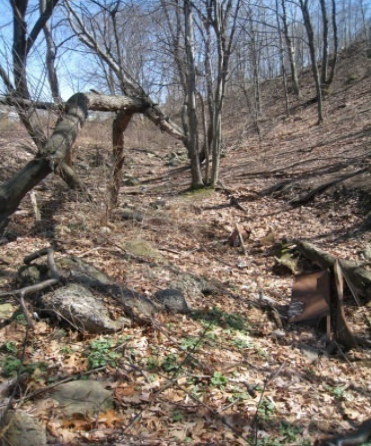
</div> <div style="flex: 1; padding-left: 10px;"> <p>No manmade stormwater conveyance system could be located in this area. This photo shows the probable flow path to the playground area. The form states that the flooding is caused by stormwater volume, velocity, and direction. There does not appear to be stormwater management controls in the development above the playground.</p> </div> </div>

Solution	6.4.5, 6.4.8, 6.4.10, 6.6.2, 6.A
----------	----------------------------------

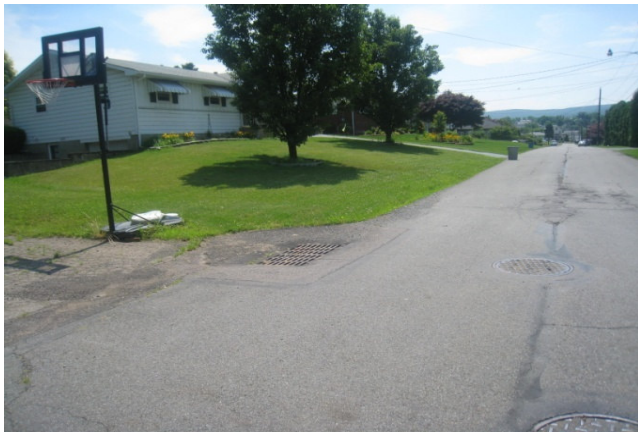
</div> <div style="width: 5%;"></div> <div style="width: 50%; padding-left: 10px;"> <p>Looking downstradient on Prince Street. A storm sewer system inlet is present. No evidence of flooding was observed.</p> </div>

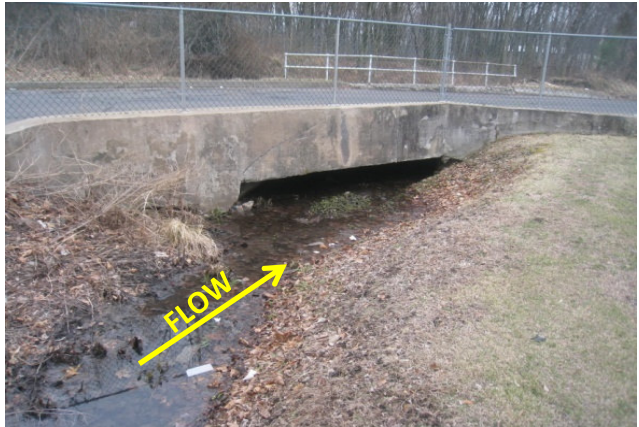
</div> <div style="flex: 2; padding-left: 10px;"> <p>Culvert at South Street over Warrior Run. The culvert is most likely undersized and would create backwater flooding during storm events. The alignment of South Street with Warrior Run is poor, which would contribute to debris clogging of the opening. The adjacent area to the right of the stream appears to be lower than the stream elevation.</p> </div> </div>

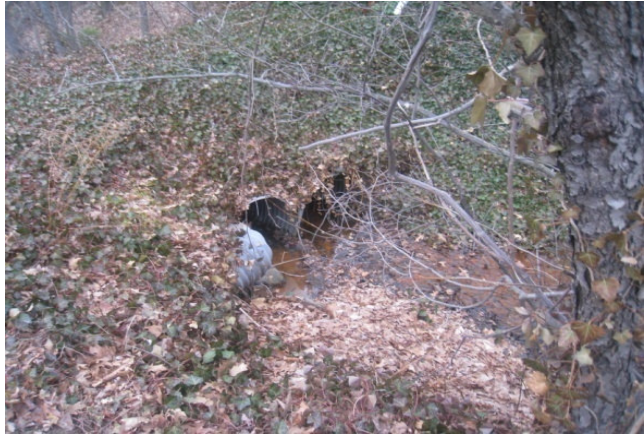
</div> <div style="flex: 2; padding-left: 10px;"> <p>Culvert system in Warrior Run upstream from South Street culvert. These culverts appear undersized and may clog from debris during larger storm events.</p> </div> </div>

Solution	5.4.2, 6.7.1, 6.A, 6.B
----------	------------------------

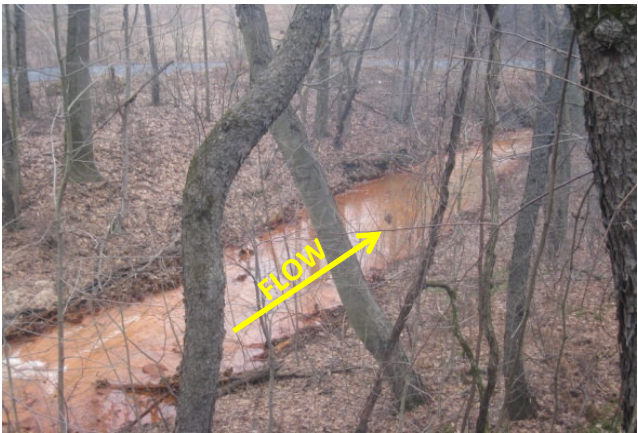
Description
	Nanticoke Creek looking downstream. Although the channel is well defined, medium to larger storms would likely overflow the streambanks.

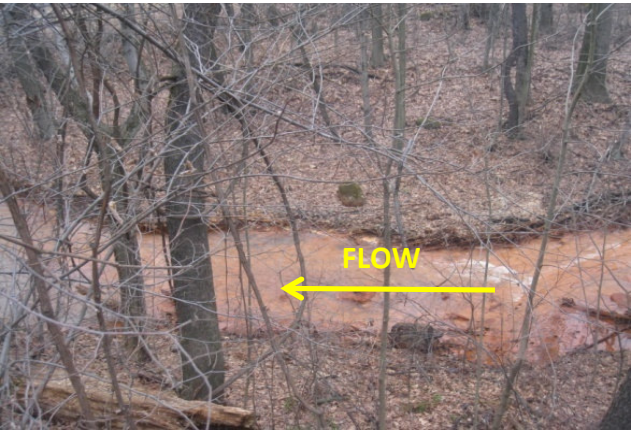
Description
	Looking along Nanticoke Creek. Water flowing in Nanticoke Creek is an orange color indicative of acid mine drainage discharge. This site is downstream of a past anthracite mining borehole.

Solution	5.4.2, 6.7.1, 6.A, 6.E
----------	------------------------

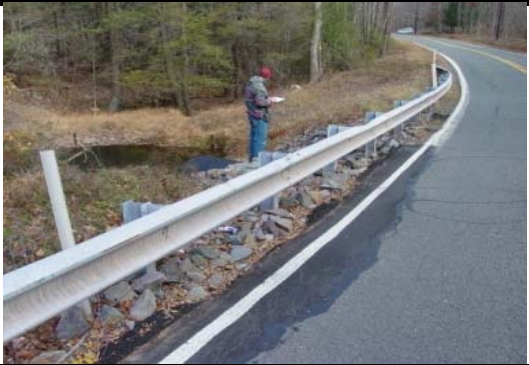
Problem Area ID:	HAZ001	Inspected By/Date:	PAD 11/22/2008
Municipality:	Hazle Township	Checked By/Date:	DEW 2/26/2010
Subwatershed:	Nescopeck Watershed

Explanation: According to preliminary analysis, an undersized culvert does not pass the design storm. Furthermore, reports state that it often becomes clogged with debris. Due to a lack of development in the area, the culvert may not need to be replaced; however, options for correction include regular maintenance as well as replacing the culvert.

Stream name:	Trib to Black Creek		
Drainage Area (mi ²):	0.88		
Calculation Method:	USGS 4189		
C (Tc):	N/A		
Storm Frequency (Yrs)	Rainfall (in)	Peak Discharge (cfs)	Unit Discharge (cfs/Ac)
2	3.40	92	0.16
5	4.22	129	0.23
10	4.95	158	0.28
25	6.10	235	0.42
50	7.16	307	0.55
100	8.43	394	0.70
*Type of Problem (Highlight all that apply):		Description	
Flooding	Deficient Bridge/Culvert	Culvert under Weston Road is a cause of flooding in the area. Culvert is subject to frequent clogging with debris and may be undersized.	
Erosion	Sedimentation		
Water/Groundwater Pollution	Other		
Potential Solutions			
The culvert under Weston road has been identified as a problem area by the Conservation District due to a history of road overtopping and upstream flooding. Based upon general field observations, this problem is believed to be caused by clogging and or the culvert being undersized. Possible solutions to this problem include A) performing regular maintenance of the culvert to keep free of debris and B) replacing the existing culvert with a larger structure.

Cost Estimates			
Option	A	B	C
Cost Range	\$500/year	\$10,000-\$20,000	N/A

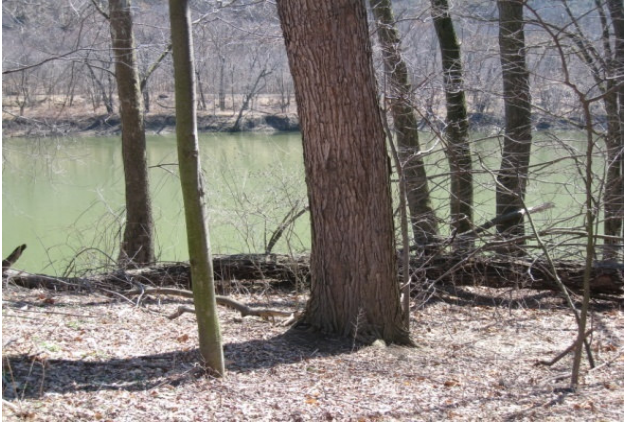
Description
	Looking at the Susquehanna River from the North Bank.

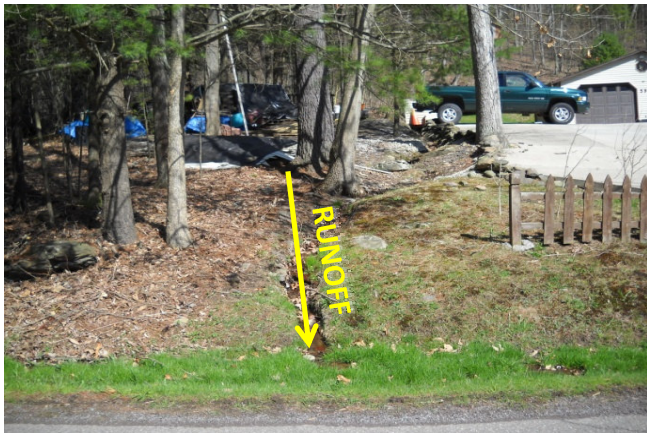
Description
	<p>This photo shows a drainage swale at 59 Indian Cave Road draining into a culvert beneath the road. A series of culverts appear along Indian Cave Road and capture stormwater coming down from the mountainous areas upslope. According to a local homeowner, the culverts are inadequate in size and the road frequently overtops.</p>

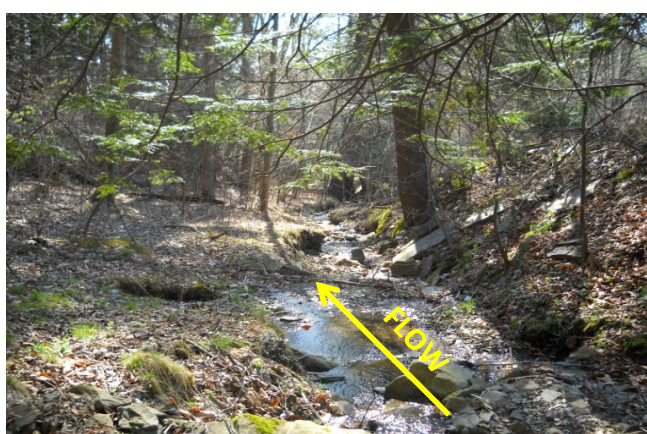
Description
	<p>This is the floodplain from the nearby hauling site located along Garden Drive.</p>

Solution	5.4.1, 5.4.2, 6.4.4, 6.4.8, 6.7.1, 6.A, 6.B
----------	---

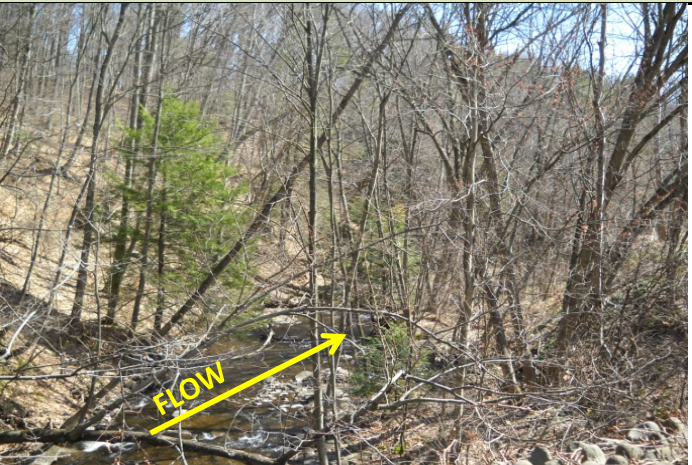
<p>This photo was taken on Old Tavern Road Bridge looking downstream. The left bank is noticeably steep consisting of an approximately 20% grade.</p>

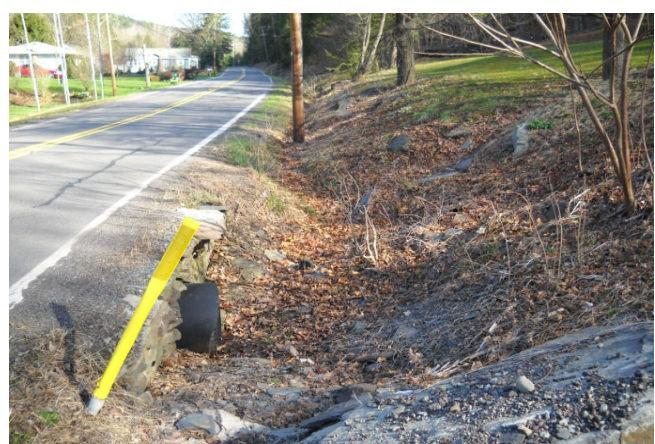
Description
	<p>This photo shows a drainage pipe which is directing flow from the east side of Swamp Road to the west side. According to the local homeowner, flooding begins on this side of Swamp Road, likely due to an insufficient culvert size.</p>

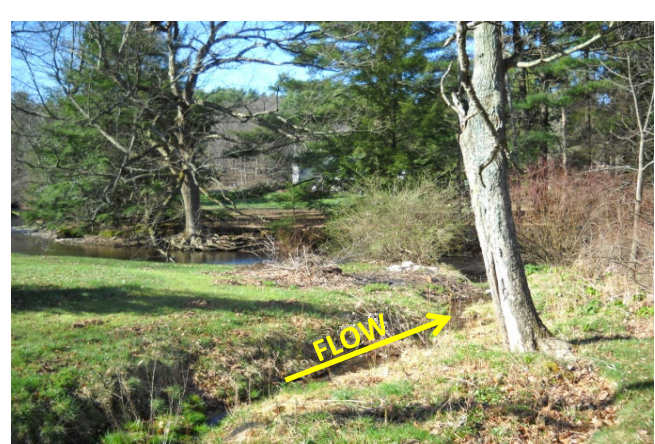
Description
	<p>This photo shows the discharge swale from the western side of Swamp Road draining toward Hunlock Creek. Multiple swales similar to this swale are present in the area.</p>

Solution	5.4.1, 5.4.2, 6.4.4, 6.4.5, 6.4.8, 6.7.1, 6.A, 6.B
----------	--

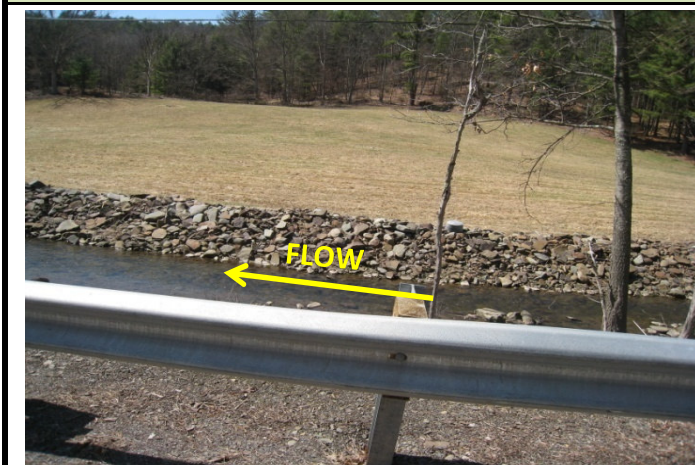
Description
Looking at the tributary to Hunlock Creek from Main Rd. near the intersection with Tavern Road.

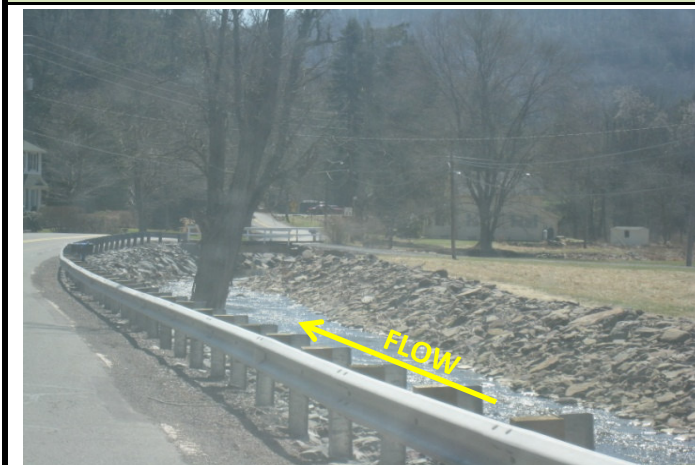
Description
Looking downstream along the tributary to Hunlock Creek. Both banks have been armored with rock riprap.

Solution	5.4.2, 6.C
----------	------------

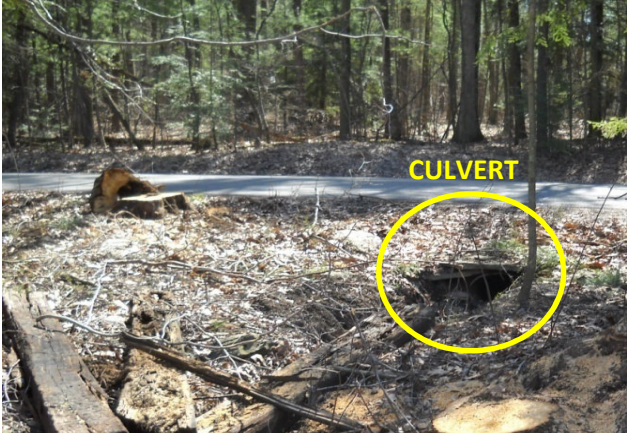
Description
	<p>This photo shows a culvert under Pike Valley Drive. According to a local homeowner, drainage problems are associated with large storms only at this location.</p>

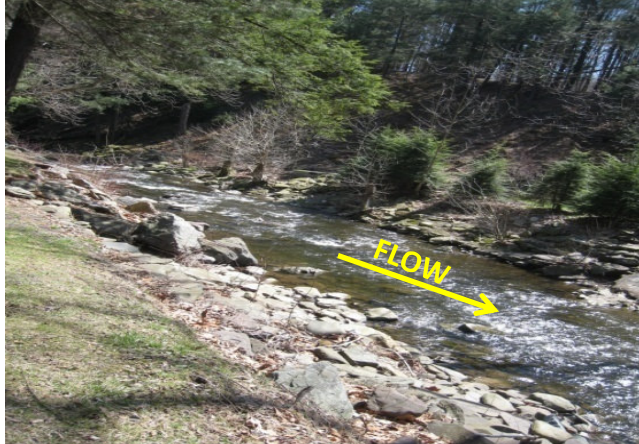
Description
	Looking upstream of the bridge, both banks are protected with rock riprap. Water within the creek appeared to be moving at a high velocity and the creek likely has a large sediment load capacity. Based on site observations, it appears that the bridge interrupts the sediment transport, resulting in the sediment deposit under the span. Once downstream of the bridge, the sediment transport likely resumes to normal levels.

Solution	5.4.1, 5.4.2, 5.6.3, 6.7.1, 6.A, 6.B, 6.C, 6.D
----------	--

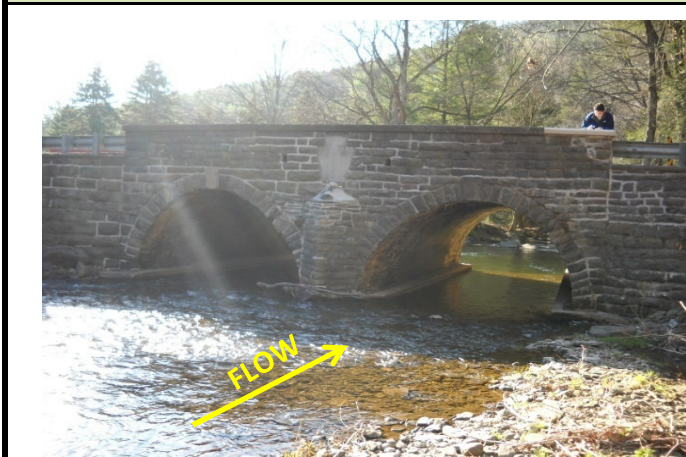
Description
Upstream of bridge looking at upstream face. Riprap is present on left bank and there is light to medium erosion on the right bank. Pier is clear of debris.

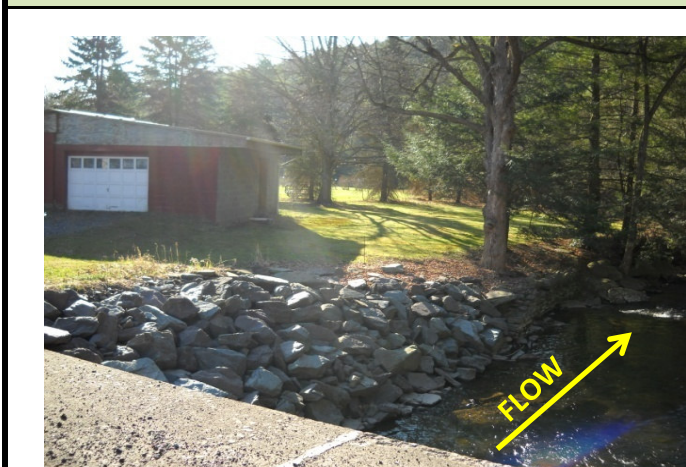
Description
View from bridge looking downstream. Riprap has been placed along the left bank for stabilization.

Solution	5.4.1, 5.4.2, 6.7.1
----------	---------------------

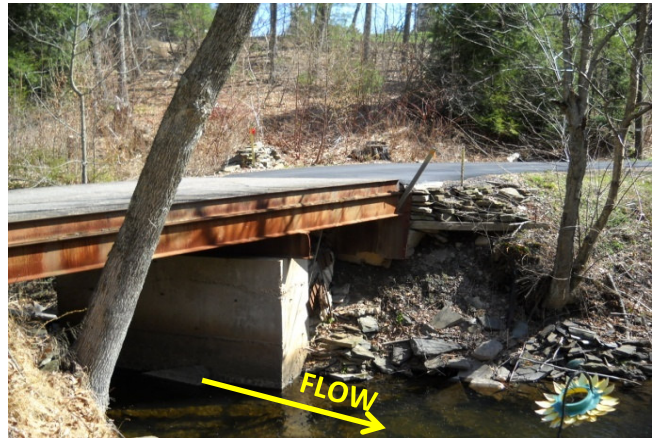
Description
	<p>Looking upstream at downstream face of Old Tavern Road Bridge. Flow is concentrated under the right span. The bridge is likely undersized, which could potentially cause flooding.</p>

Solution	5.4.1, 5.4.2, 5.6.3, 6.7.1, 6.A, 6.B
----------	--------------------------------------

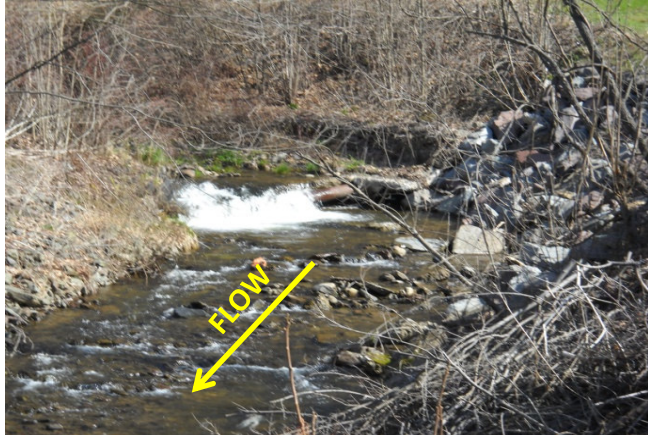
Description
	<p>This photo, taken from Main Road Bridge looking upstream, shows the gas pipeline that runs through the creek. Riprap has been placed at the bend on the left bank just downstream of the pipe in an attempt to stabilize the channel and pipe.</p>

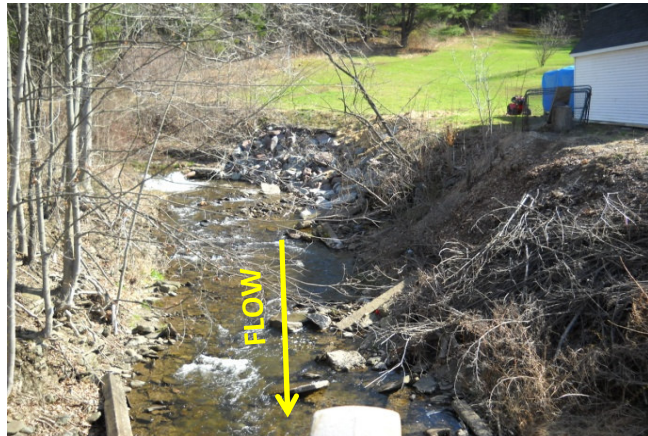
Problem Area - Map ID:	HUN012	<p style="text-align: center;">Comments</p> <p>The Conservation District reported erosion on both the left and right streambanks. A gas pipeline runs through the creek, creating an obstruction to flow. The concrete encasement over the gas pipeline has been eroded leaving the pipe exposed. A large flow could potentially damage the pipe causing a gas leak.</p>
Municipality:	Hunlock Township	
Subwatershed:	Hunlock Creek	
Stream name:	Hunlock Creek	
Inspected By/Date:	PAK 4/17/2009	
Checked By/Date:	MJW 1/11/2010	
Type of Problem (Highlighted):		
1	Flooding	
2	Deficient bridge/culvert	
3	Erosion	
4	Sedimentation	
5	Water/Groundwater Pollution	
6	Other

Description
	<p>This photo, also taken from Main Road Bridge looking upstream, shows streambank erosion along the creek. Erosion is most prevalent along the left bank looking downstream. The private residence is located adjacent the eroding bank.</p>

Solution	5.4.1, 5.4.2, 5.6.3, 6.7.1, 6.A, 6.E
----------	--------------------------------------

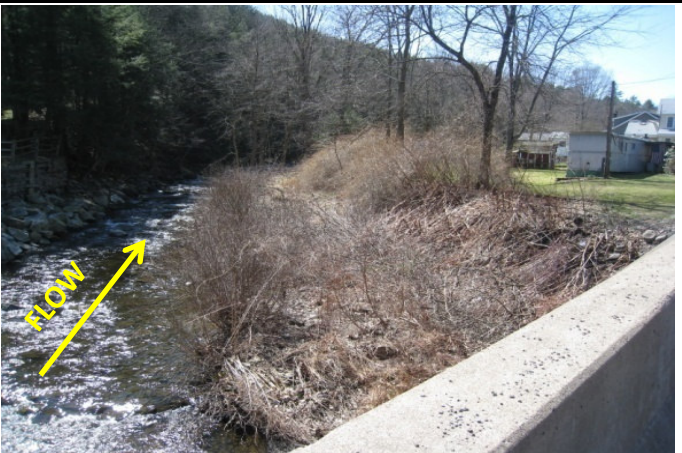
Description
	Looking Downstream along right (western) bank at buffer. Although not visible in the photograph, some sediment deposition is present under the western bridge span.

Solution	5.4.1, 5.4.2
----------	--------------

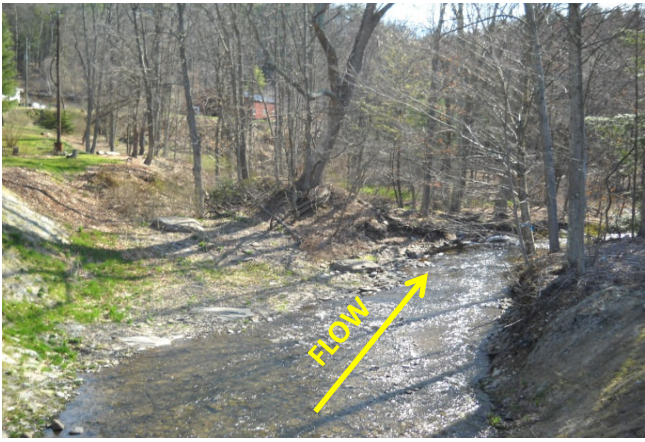
</div> <div style="width: 50%; padding-left: 10px;"> <p>View from Oakdale Drive culvert looking downstream. Buffer is present and geosynthetic netting has been placed on the left bank in an attempt to stabilize bank erosion. Problem area HUN012 is located approximately 500 feet downstream of this location.</p> </div>

Solution	5.4.2, 6.7.1
----------	--------------

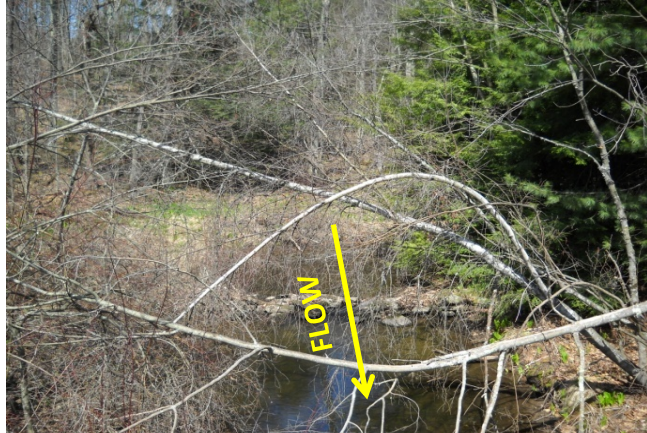
Problem Area - Map ID:	HUN015 & HUN016	Comments
Municipality:	Hunlock Township	Streambank erosion and stream crossing damage were reported by the Conservation District at the site near Golf Course Road (HUN016).
Subwatershed:	Hunlock Creek	
Stream name:	Trib. To Roaring Brook	
Inspected By/Date:	PAK 4/17/2009	
Checked By/Date:	MJW 1/11/2010	
Type of Problem (Highlighted):		
1	Flooding	
2	Deficient bridge/culvert	
3	Erosion	
4	Sedimentation	
5	Water/Groundwater Pollution	
6	Other

Description
	<p>This photo of site HUN015 was taken from the private road bridge off of Golf Course Road looking upstream. There are several downed trees and sediment deposits in this area. The banks have begun to erode.</p>

Solution	5.4.2, 5.6.3, 6.7.1, 6.B, 6.C
----------	-------------------------------

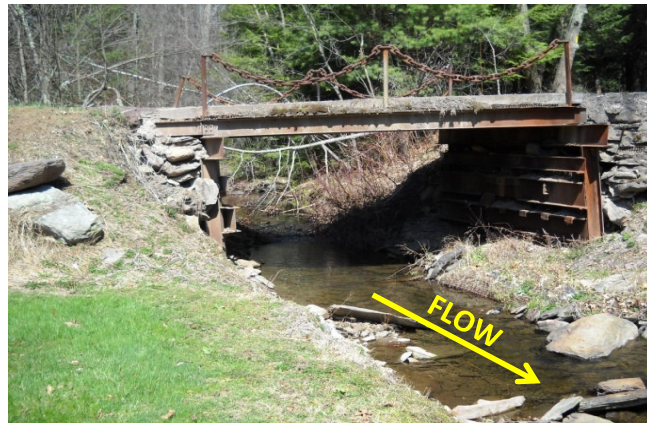
Description
	<p>This photo was taken looking at the downstream face of the private bridge. The bridge appears to be an old stone bridge that was retrofitted with steel beams and abutments.</p>

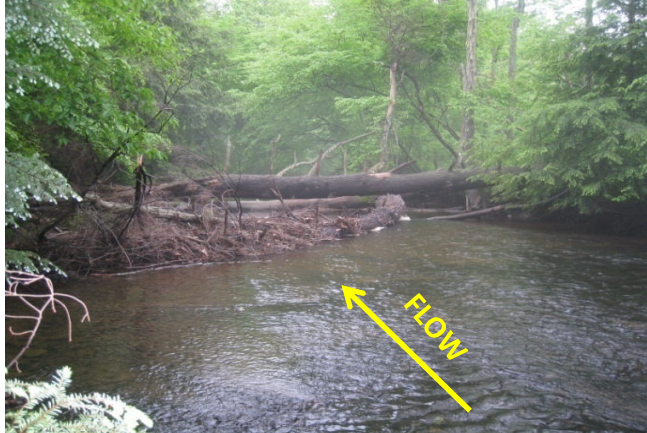
Problem Area - Map ID:	HNT001 & NCB001	Comments
Municipality:	Huntington Twp, New Columbus Boro	The Conservation District reported flooding at two (2) locations along Pine Creek. Streambank erosion is also present along Pine Creek. The erosion has resulted in tree collapse into the creek, creating an obstruction (NCB001). This obstruction is the likely the cause of upstream flooding at a private residence (HNT001).
Subwatershed:	Huntington Creek	
Stream name:	Pine Creek	
Inspected By/Date:	PAK 5/28/2009	
Checked By/Date:	MJW 1/11/2010	
Type of Problem (Highlighted):		
1	Flooding	
2	Deficient bridge/culvert	
3	Erosion	
4	Sedimentation	
5	Water/Groundwater Pollution	
6	Other

</div> <div style="width: 50%; padding-left: 10px;"> <p>Looking downstream at trees that have fallen across Pine Creek (NCB001). From visual observations, it appears this obstruction has existed for some time, as evidenced by the debris which has accumulated along the left bank.</p> </div> </div>

Solution	5.4.2, 6.A
----------	------------

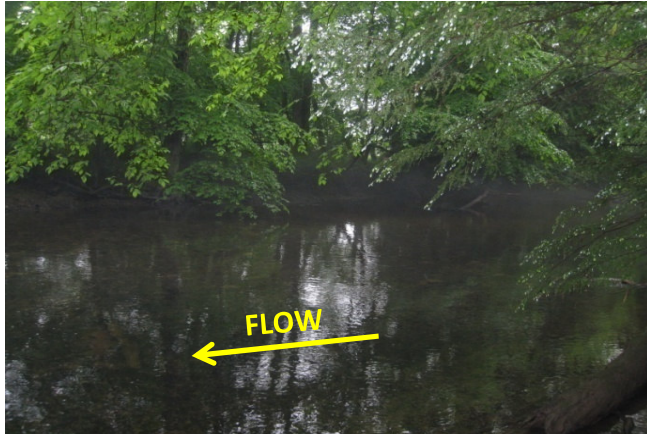
</div> <div style="width: 50%; padding-left: 10px;"> <p>Downstream of obstruction at NCB001. The creek has acceptable buffers on both sides.</p> </div> </div>

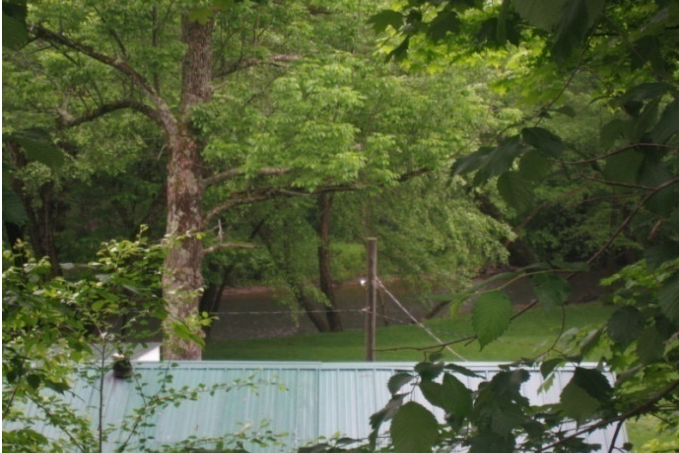
Problem Area - Map ID:	HNT002	Comments
Municipality:	Huntington Twp	The Conservation District reported streambank erosion along Huntington Creek behind 915, 917, and 919 Waterton Road.
Subwatershed:	Huntington Creek	
Stream name:	Huntington Creek	
Inspected By/Date:	PAK 5/28/2009	
Checked By/Date:	DEW 1/15/2010	
Type of Problem (Highlighted):		
1	Flooding	
2	Deficient bridge/culvert	
3	Erosion	
4	Sedimentation	
5	Water/Groundwater Pollution	
6	Other

<div style="width: 50%; padding-left: 10px;"> <p>View of Huntington Creek from Waterton Road. Due to "No Trespassing" signage, the condition of the streambank could not be observed.</p> </div> </div>

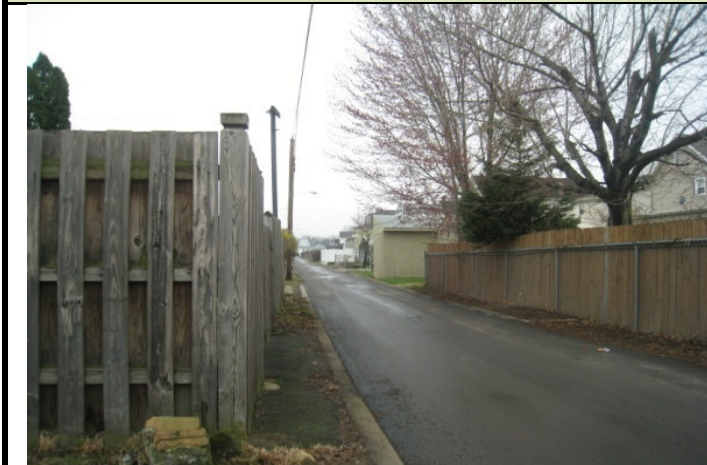
Description
Looking toward KNB003, no problems observed.

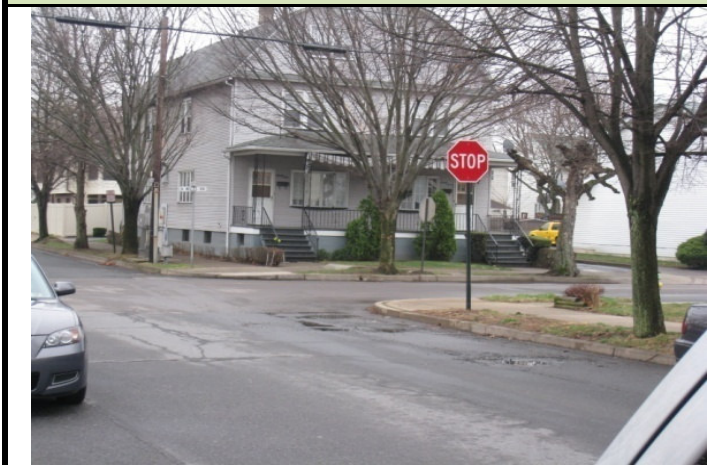
Description
Looking at the intersection of Hoyt St. and Welles Ave. Storm sewers are present, flooding problems not observed. Problem area KNB006 was located in a school playground that was currently in use, preventing access.

Solution	5.7.1, 5.7.2, 5.9.1, 6.4.5, 6.A, 6.B
----------	--------------------------------------

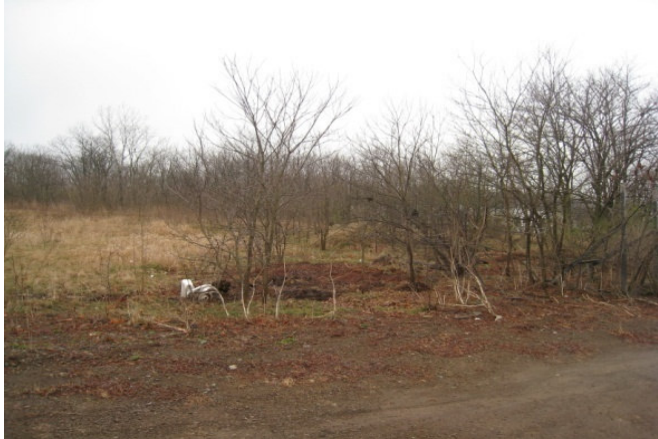
Problem Area - Map ID:	KNB008	Comments
Municipality:	Kingston Borough	Kingston Borough reported flooding in this area. Cause of the flooding appears to be accumulation of debris which is blocking an existing culvert.
Subwatershed:	Susquehanna River	
Stream name:	Local Drainage	
Inspected By/Date:	PAK 4/3/2009	
Checked By/Date:	DEW 1/15/2010	
Type of Problem (Highlighted):		
1	Flooding	
2	Deficient bridge/culvert	
3	Erosion	
4	Sedimentation	
5	Water/Groundwater Pollution	
6	Other

Description	
Looking at upslope end of culvert. Culvert discharge could not be located.

Solution	6.A, 6.B
----------	----------

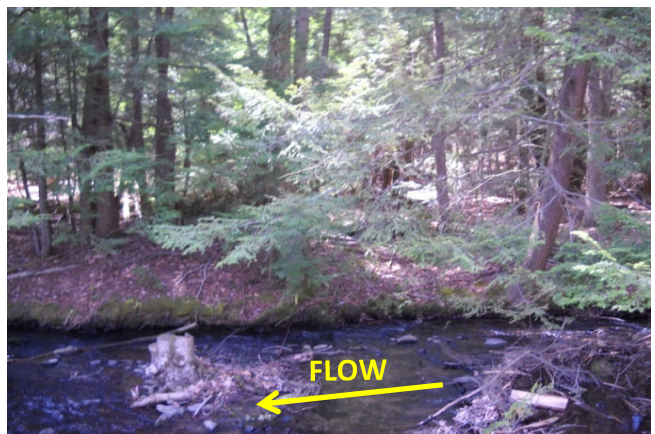
Problem Area - Map ID:	LAK002	Comments
Municipality:	Lake Township	Lake Township reported flooding at this location. Based on field observations, it appears that large storm events may cause flooding of Gordon Road and a nearby house.
Subwatershed:	Harvey Creek	
Stream name:	Fades Creek	
Inspected By/Date:	PAK 4/17/2009	
Checked By/Date:	DEW 1/27/2010	
Type of Problem (Highlighted):		
1	Flooding	
2	Deficient bridge/culvert	
3	Erosion	
4	Sedimentation	
5	Water/Groundwater Pollution	
6	Other

<div style="margin-left: 20px;"> <p>Right bank the channel. Accumulated debris and branches in the channel shown in this photo may cause an obstruction to the stream flow.</p> </div> </div>

Solution	5.4.2, 6.7.1, 6.A
----------	-------------------

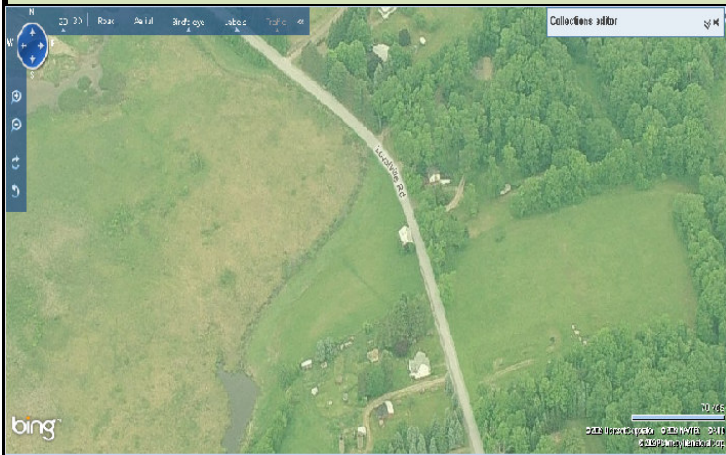
Problem Area - Map ID:	LAK003	Comments
Municipality:	Lake Township	The Conservation District reported flooding at this location; however, the problem was not able to be located during field observation. After review of submitted documentation, it was determined that an incorrect location was provided on the form.
Subwatershed:	Harvey Creek	
Stream name:	Tributary to Harvey Creek	
Inspected By/Date:	PAK 4/17/2009	
Checked By/Date:	DEW 1/27/2010	
Type of Problem (Highlighted):		
1	Flooding	
2	Deficient bridge/culvert	
3	Erosion	
4	Sedimentation	
5	Water/Groundwater Pollution	
6	Other

Description
	Aerial photograph showing the property address provided on the form. No flooding problems observed.

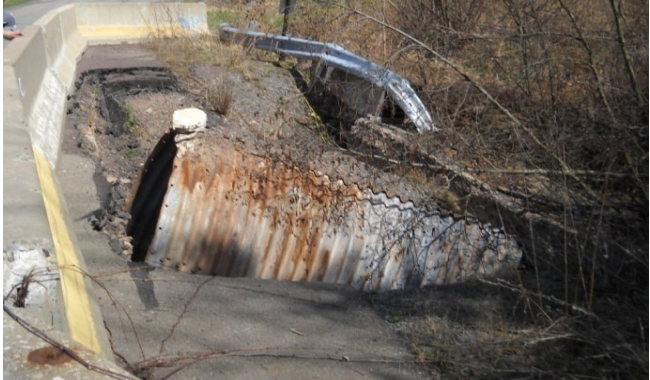
Problem Area - Map ID:	LAK004	Comments
Municipality:	Lake Township	The Conservation District reported several problems including flooding, deficient culvert, and erosion at this location.
Subwatershed:	Bowmans Creek	
Stream name:	Trib. To Beaver Run	
Inspected By/Date:	PAK 4/17/2009	
Checked By/Date:	DEW 1/27/2010	
Type of Problem (Highlighted):		
1	Flooding	
2	Deficient bridge/culvert	
3	Erosion	
4	Sedimentation	
5	Water/Groundwater Pollution	
6	Other

<div style="width: 55%; padding-left: 10px;"> <p>Culvert failure along East Sorber Mountain Rd. Embankment erosion has resulted in the undermining failure of this culvert. A local landowner indicated that half of the culvert was repaired; however, the other half of the culvert remains in disrepair. Accumulated debris was found at the opening of the culvert.</p> </div> </div>

Solution	5.4.2, 5.6.3, 6.7.1, 6.A, 6.B
----------	-------------------------------

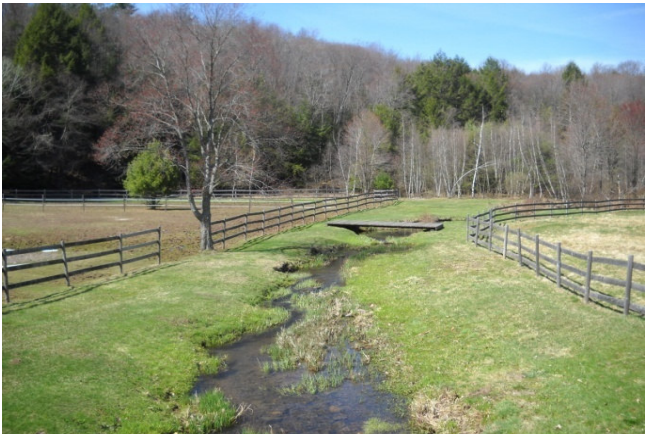
<div style="width: 55%; padding-left: 10px;"> <p>Foot bridge over the tributary. A local homeowner indicated this area was completely flooded during the 2006 storm.</p> </div> </div>

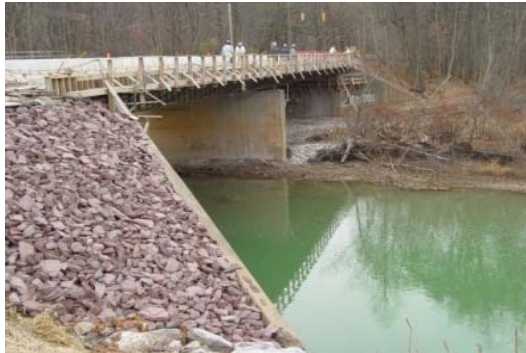
Problem Area ID:	NSB001	Inspected By/Date:	PAD 11/12/2008
Municipality:	Nescopeck Borough	Checked By/Date:	DEW 2/26/2010
Sub watershed:	Nescopeck Watershed

Explanation: 339 Bridge and the accompanying Railroad Bridge have caused sediment to be deposited under the western spans of the bridges. Because sediment was being trapped here, the northeastern stream bank began to erode causing undercutting along Welsh Ave. Upon site observations, the stream has been stabilized with riprap in the eroded area. Options for correction involve regular maintenance to make sure that the sediment and debris caught under the bridges is removed.

<p>The adjacent railroad and SR 339 bridges have been identified as a problem area by the conservation district due to a history of debris accumulation, sedimentation under the bridges, and significant erosion downstream of the bridges. Based upon general field observations, this problem looks to have been addressed. To prevent future problems, possible actions are to A) perform regular debris and sediment removal at the bridge.</p>			
Cost Estimates			
Option	A	B	C
Cost Range	\$1,000 per year	N/A	N/A

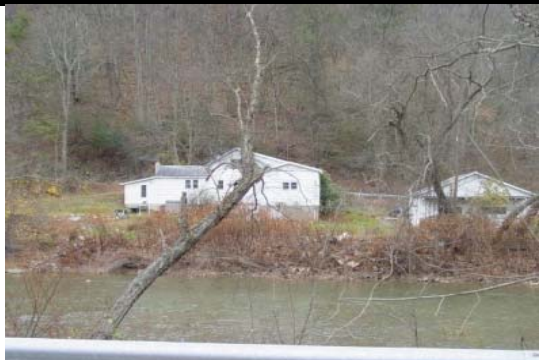
Problem Area ID:	NST001	Inspected By/Date:	PAD 11/12/2008
Municipality:	Nescopeck Township	Checked By/Date:	DEW 2/26/2010
Subwatershed:	Nescopeck Watershed

Explanation: Nescopeck Creek has caused severe channel erosion and undercutting along a 1 mile stretch of land alongside Black Creek Rd. Documentation notes that the entire area has flooded with 3-4 inches of flowing water. Options for correction include stabilizing the banks, floodproofing the houses, or providing upstream impounding to reduce the flow in the channel.

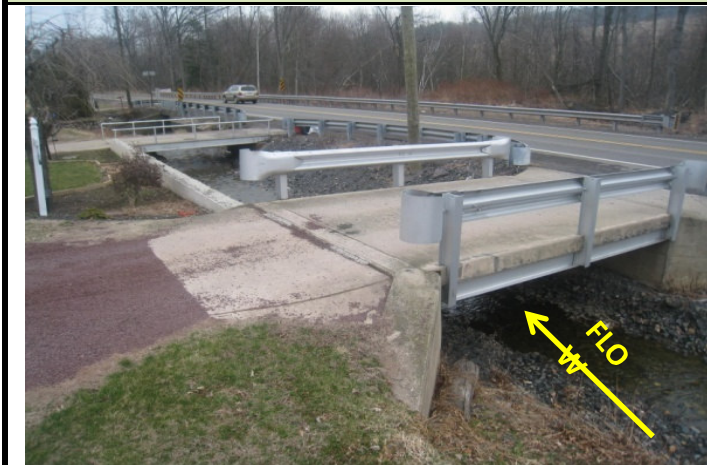
Problem Area - Map ID:	NEW001	Comments
Municipality:	Newport Township	The Conservation District reported numerous problems at this location. According to local homeowners, the channel was constructed as part of a stream realignment for mining operations. A combination of sedimentation from mine runoff and backwater from bridges results in frequent flooding of the area.
Subwatershed:	Newport/Nanticoke Creek	
Stream name:	S. Branch Newport Creek	
Inspected By/Date:	PAK 3/26/2009	
Checked By/Date:	DEW 1/27/2010	
Type of Problem (Highlighted):		
1	Flooding	
2	Deficient bridge/culvert	
3	Erosion	
4	Sedimentation	
5	Water/Groundwater Pollution	
6	Other

Description
Series of privately owned bridges along W. Kirmar Ave. In addition to these two privately owned bridges there are PADOT bridges that carry Kirmar Ave over Newport Creek nearby.

Solution	5.4.2, 5.6.3, 6.7.1, 6.A, 6.B, 6.C
----------	------------------------------------

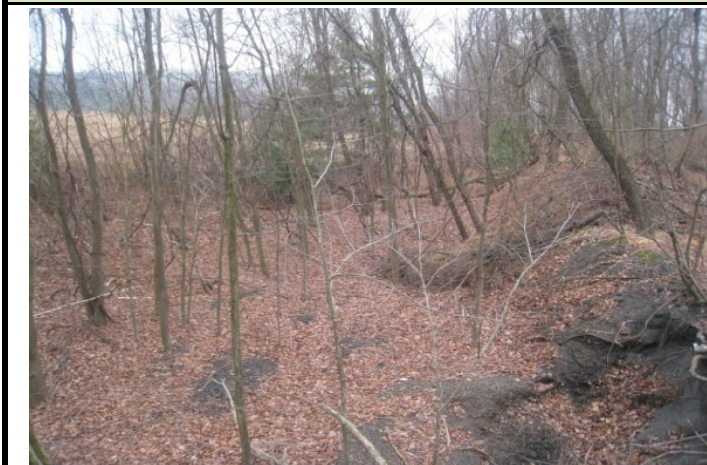
Description
Former location of Newport Creek. The creek was realigned approximately 100 years ago and the bed has dried up since. Remnants of the streambed are still visible in this location.

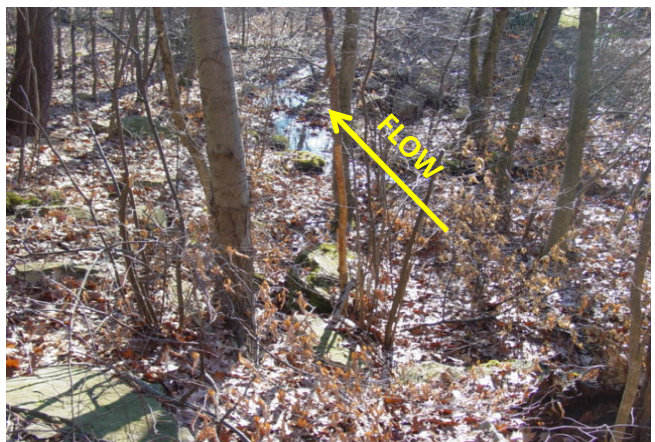
Problem Area - Map ID:	NUA001	Comments
Municipality:	Nuangola Borough	Flooding was documented at this location by Nuangola Borough. A culvert conveys stormwater under North End Road to a drainage swale, which discharges to Nuangola Lake. The culvert size appears to be insufficient to convey larger flows.
Subwatershed:	Wapwallopen	
Stream name:	Nuangola Lake	
Inspected By/Date:	PAK12/3/2008	
Checked By/Date:	MJW 1/12/2010	
Type of Problem (Highlighted):		
1	Flooding	
2	Deficient bridge/culvert	
3	Erosion	
4	Sedimentation	
5	Water/Groundwater Pollution	
6	Other

<div style="padding-left: 20px;"> <p>Looking downstream from the culvert. A small winding channel is noted through the trees. A buffer is maintained; however, the channel is not very deep and probably floods often. The forms indicate that the duration of flooding can last for weeks. The recommended solution is to raise the elevation of North End Road and construct new culverts.</p> </div> </div>

Solution	5.4.2, 5.4.3, 6.7.1, 6.A, 6.B
----------	-------------------------------

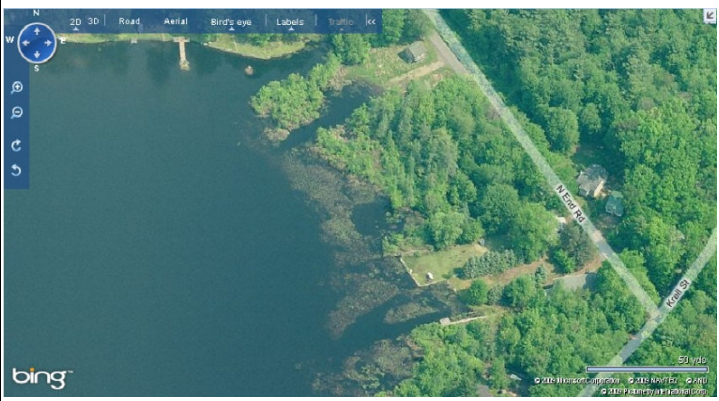
Aerial photograph of problem area reported by Nuangola Borough. During the time of the field observation, it appeared that inadequate storm sewer systems cannot convey fast moving runoff from the steep roadways.

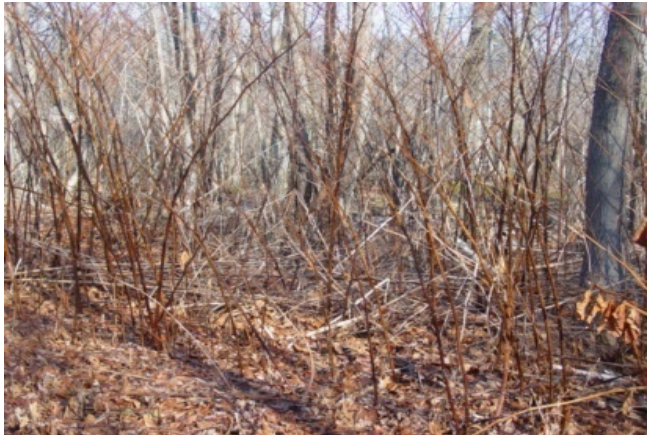
</div> <div style="width: 5%;"></div> <div style="width: 45%;"> <p>Looking at the woods surrounding the trailer. End Street appears to be at a higher elevation than the adjacent area.</p> </div>

Solution	5.4.2, 6.A, 6.B
----------	-----------------

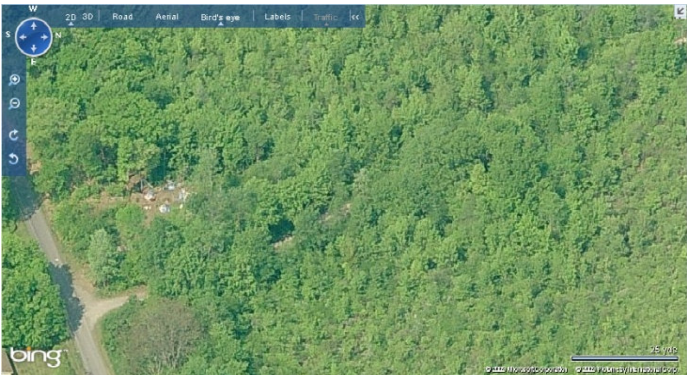
</div> <div style="width: 5%;"></div> <div style="width: 45%;"> <p>Trailer is located in a large wooded buffer area adjacent to Nuangola Lake. Nuangola Lake is located towards the upper right hand corner of the picture.</p> </div>
